# **Arborist Associates Ltd.**

## **An Arboricultural Assessment of the Tree and Hedge Vegetation on Lands at 'Money Little and Tinahask', Arklow, Co. Wicklow.**

**Prepared for: Castlethorn Arklow Limited (808309)**

**Date: 25<sup>th</sup> September 2026**

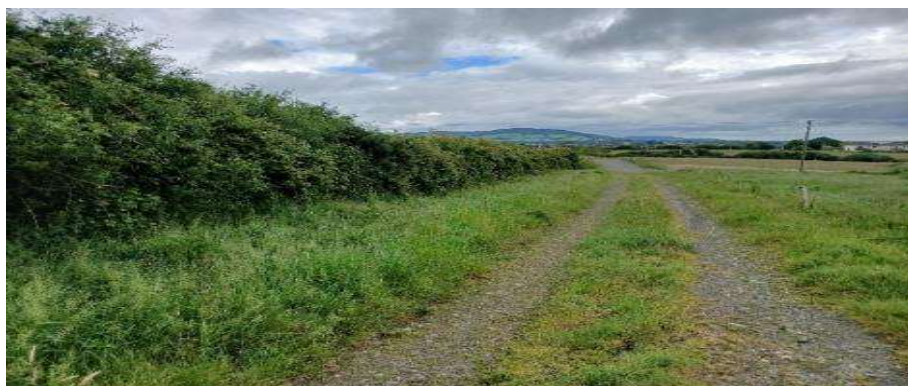
| Tree No. | Tree Species | Ht (m) | Stem Dia | Branch Spread (m) | | | | C - Ht. (m) | Age Class | Phys Con | Structural Comments | Preliminary Recommendations | ULE | Cat Grade | RPA (m) | | | | |
|---|---|---|---|---|---|---|---|---|---|---|---|---|---|---|---|---|---|---|---|
| Hedge No.1 | Bramble spp<br><i>Rubus</i><br>Common Gorse<br><i>Ulex</i><br><i>Europeaus</i><br>Hawthorn<br><i>Crataegus monogyna</i><br>Honey Suckle<br>Rose<br><i>Rosa spp</i><br>Blackthorn<br><i>Prunus spinosa</i><br>Dog Rose<br><i>Rosa canina</i> | <p>It extends from the south of the bridge and forms the field boundary along the railway line.</p> <p>It is of a mature age class in fair condition physiologically and structurally. It is a broad hedge and has been trimmed in the past to contain its size and shape. Its lower crown along the rail track has been trimmed regularly for rail clearance.</p> <div></div> <table><tr><td>A3</td><td>--</td><td>A 2E, A3W</td><td>--</td></tr></table> | | | | | | | | | | A3 | -- | A 2E, A3W | -- | It will require ongoing maintenance to contain hedge structure and safety towards the railway line. | 20+ | B2 | -- |

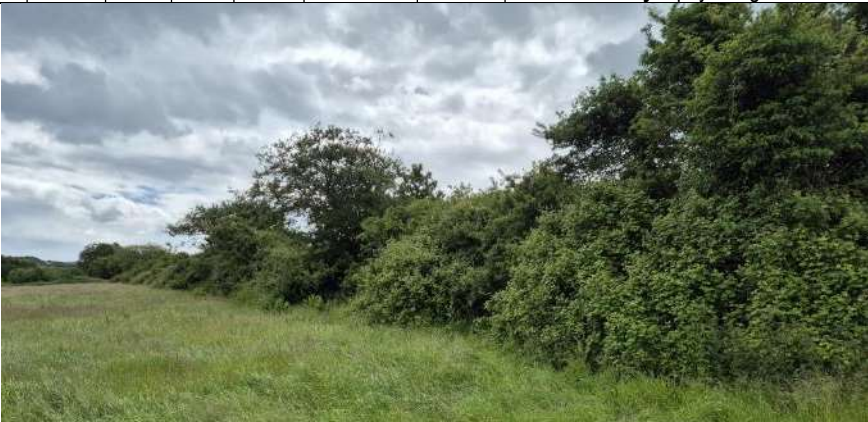
| Tree No. | Tree Species | Ht (m) | Stem Dia | Branch Spread (m) | | | | C - Ht. (m) | Age Class | Phys Con | Structural Comments | Preliminary Recommendations | ULE | Cat Grade | RPA (m) |
|---|---|---|---|---|---|---|---|---|---|---|---|---|---|---|---|
| T63 | <b>Beech</b><br><i>Fagus sylvatica</i> | 7 | 360 | 4 | 4 | 3 | 3 | 2 | Early Mature | Fair | Fair/ Poor<br>It is growing up as part of the hedge line and is significantly stunted for its age with minimal extension growth. It also has a poor formed stem, suggesting it was cut back in the past or impacted by coastal winds. It lost a limb to its north side and there is a cavity at this point. It has merit for its unique shape and form. | It requires no work at the present time. | 10-20 | C1 | 4.3 |

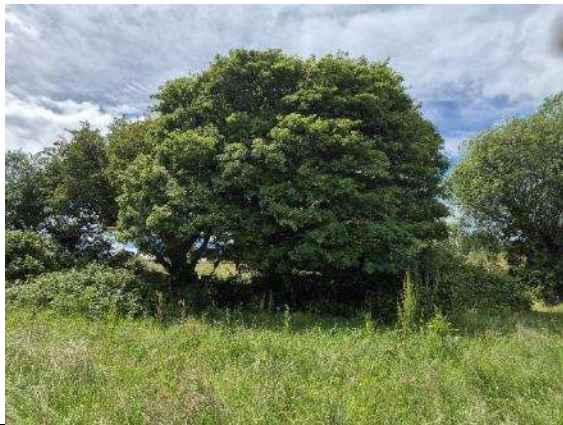
| Tree No. | Tree Species | Ht (m) | Stem Dia | Branch Spread (m) | | | | C - Ht. (m) | Age Class | Phys Con | Structural Comments | Preliminary Recommendations | ULE | Cat Grade | RPA (m) |
|---|---|---|---|---|---|---|---|---|---|---|---|---|---|---|---|
| T75 | <b>Oak</b><br><i>Quercus robur</i> | 10 | 560/<br>270 | 3 | 4 | 0 | 8 | 3 | Early<br>Mature | Fair | Fair<br>It is growing along the top of the hedgerow bank. It is suppressed by Ivy and has a very low squat crown and is slightly sparse. A Hawthorn has grown up entangled in its lower crown. There is some decayed areas at its base where limbs failed in the past. There is a large hanger caught in its lower crown which has failed from a neighbouring tree. | Remove hanging branch.<br>Cut Ivy at ground level. | 20+ | B2 | 7.5 |

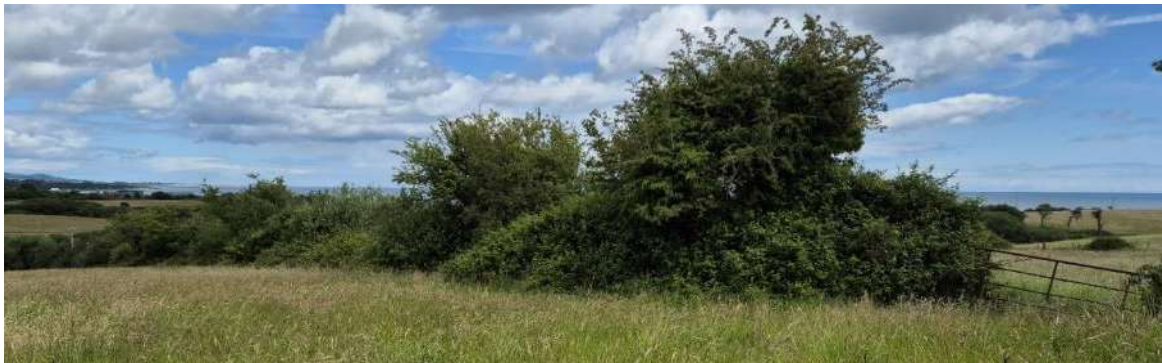
| Tree No. | Tree Species | Ht (m) | Stem Dia | Branch Spread (m) | | | | C - Ht. (m) | Age Class | Phys Con | Structural Comments | Preliminary Recommendations | ULE | Cat Grade | RPA (m) |
|---|---|---|---|---|---|---|---|---|---|---|---|---|---|---|---|
| Woodland No.1 | <b>Goat Willow</b><br><i>Salix caprea</i><br><b>Blackthorn</b><br><i>Prunus spinosa</i><br><b>Hazel</b><br><i>Corylus avellana</i><br><b>Bramble</b><br><i>Rubus fruticosus</i><br><b>Dog Rose</b><br><i>Rosa canina</i> | <b>It forms an intersection between hedge Nos.4, 5, 6 and Woodland No.2 and has merged with the hedges.</b><br>It is of an early mature age class in fair condition physiologically and structurally. It has expanded out on either side of the original townland boundary to create the current woodland block. It is dominated by Goat Willow and blackthorn and forms an area of dense cover with limited access. | | | | | | | | | | Requires no work at the present time. | -- | B2/ B3 | 4.0 |

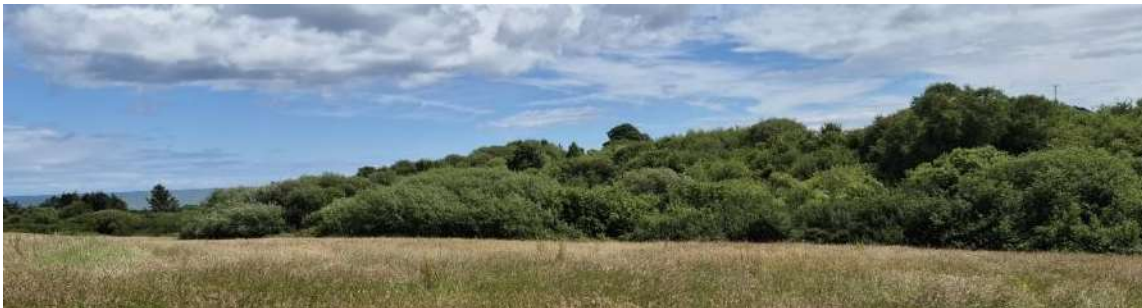
| Tree No. | Tree Species | Ht (m) | Stem Dia | Branch Spread (m) | | | | C - Ht. (m) | Age Class | Phys Con | Structural Comments | Preliminary Recommendations | ULE | Cat Grade | RPA (m) | | | | | | | | |
|---|---|---|---|---|---|---|---|---|---|---|---|---|---|---|---|--|--|--|--|--|--|--|--|
| Woodland No.2 | <b>Goat Willow</b><br><i>Salix caprea</i><br><b>Blackthorn</b><br><i>Prunus spinosa</i><br><b>Bramble</b><br><i>Rubus fruticosus</i><br><b>Dog Rose</b><br><i>Rosa canina</i> | <b>It extends eastwards from woodland No.1 along the site areas southern boundary.</b><br>It is of an early mature age class in fair condition physiologically and structurally. It consists of an area of naturalised linear woodland. It has grown up with in a valley depression area. It has expanded out on either side of the original townland boundary to create the current woodland block. It is predominately Willow and Blackthorn, with has limited the access. Dense Bramble has also begun to grow up and cover the area. It forms an area of habitat cover. | | | | | | | | | | Requires no work at the present time. | -- | B2/<br>B3 | 3.6 | | | | | | | | |

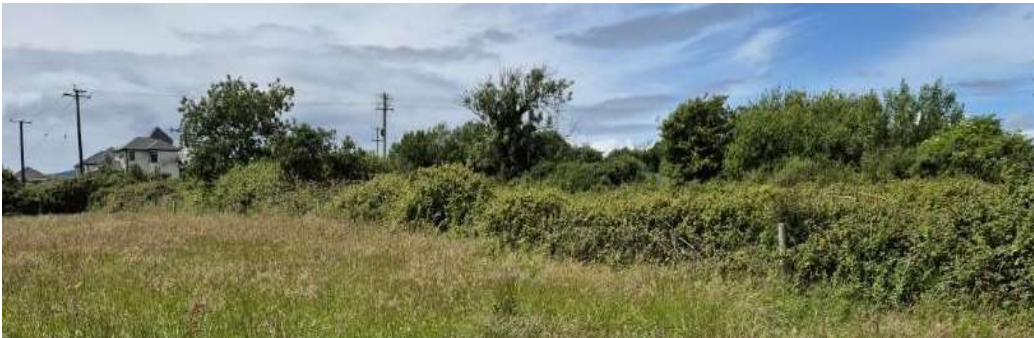
| Tree No. | Tree Species | Ht (m) | Stem Dia | Branch Spread (m) | | | | C - Ht. (m) | Age Class | Phys Con | Structural Comments | Preliminary Recommendations | ULE | Cat Grade | RPA (m) | |
|---|---|---|---|---|---|---|---|---|---|---|---|---|---|---|---|---|
| Hedge No.16 | <b>Bramble spp</b> <i>Rubus</i><br><b>Blackthorn</b> <i>Prunus spinosa</i><br><b>Hawthorn</b> <i>Crataegus monogyna</i><br><b>Oak</b> <i>Quercus robur</i><br><b>Dog Rose</b> <i>Rosa canina</i> | <b>It runs at ninety degrees to hedge No.15 forming part of the site areas northern boundary.</b><br>It is of an early mature age class in fair condition physiologically and poor condition structurally. There was limited hedge here and the wire fence has provided a growth area for the Bramble. There are two self-seeded young Oaks developing above the Bramble growth. | | | | | | | | | | | It would benefit from general tidying works and bulking up with some additional native hedge planting to create a more structured and continuous hedge. | -- | C2 | -- |

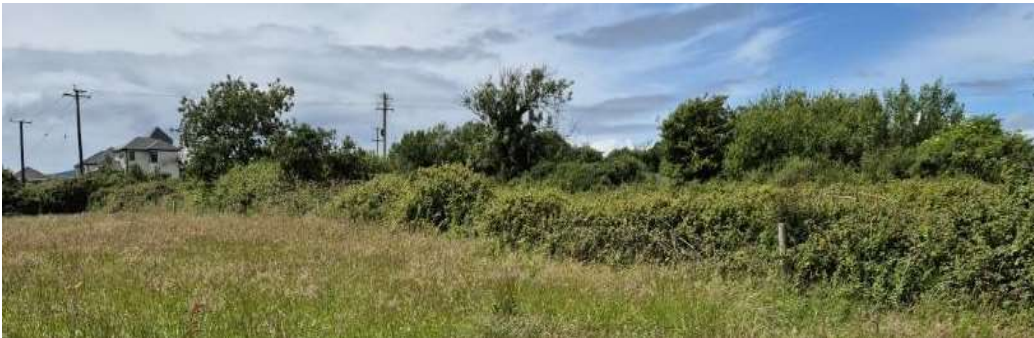
| Tree No. | Tree Species | Ht (m) | Stem Dia | Branch Spread (m) | | | | C - Ht. (m) | Age Class | Phys Con | Structural Comments | Preliminary Recommendations | ULE | Cat Grade | RPA (m) | |
|---|---|---|---|---|---|---|---|---|---|---|---|---|---|---|---|---|
| Hedge No.17 | <b>Bramble spp</b> <i>Rubus</i><br><b>Blackthorn</b> <i>Prunus spinosa</i><br><b>Hawthorn</b> | <b>It extends on from hedge No.16 &amp; 26 along part of the site areas northern boundary.</b><br>It is of an early mature age class in fair/ poor condition physiologically and structurally. It has grown up around the wire fence line and its overrun with Bramble in parts and this has smothered out other species. | | | | | | | | | | | It would benefit from general tidying works and bulking up with some additional native | -- | C2 | -- |

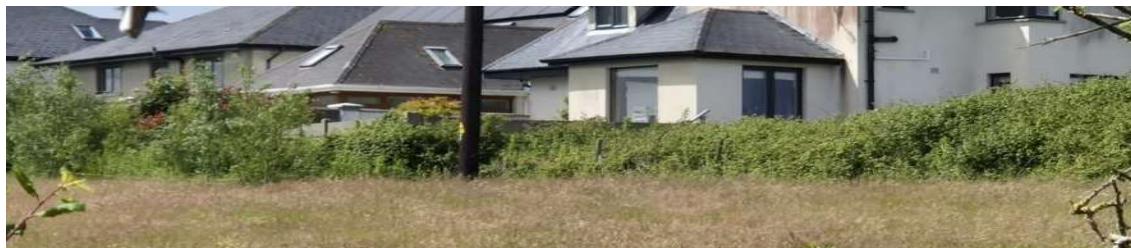
| | | | | | | | | | | | | | | | | |
| Tree No.6 | Oak<br>Quercus robur | 6 | #150 | 2 | 2 | 2 | 2 | 0.5 | Young | Fair | Fair<br>It is growing up within the open field out from the boundaries, I suspect it seeded naturally. The area around it has gone unmanaged and it has naturalised as a result. | It requires no work at the present time. | 40+ | C1 | 1.8 | | | | |
| Hedge No.18 | Hawthorn<br>Crataegus monogyna | It extends east west between fields within the site area.<br>It is of a young age class having been recently planted in fair condition physiologically and structurally. It is growing along the wire fence line which divides the fields. It is suppressed by grass and weeds along its base.<br><table><tr><td>A1</td><td>--</td><td>A0.5N, A0.5S</td><td>--</td></tr></table><br>

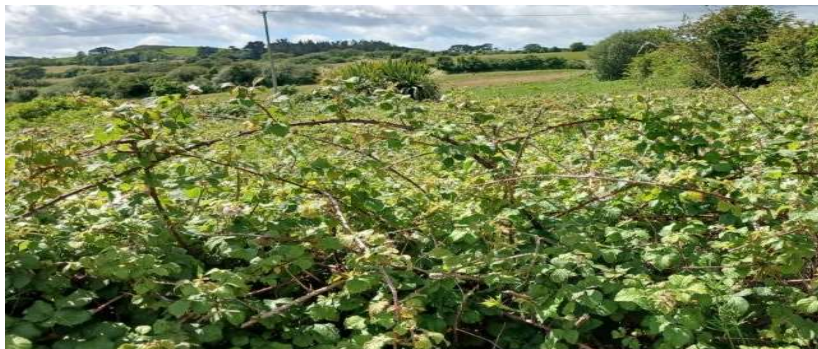
| Tree No. | Tree Species | Ht (m) | Stem Dia | Branch Spread (m) | | | | C - Ht. (m) | Age Class | Phys Con | Structural Comments | Preliminary Recommendations | ULE | Cat Grade | RPA (m) | | | | |
|---|---|---|---|---|---|---|---|---|---|---|---|---|---|---|---|---|---|---|---|
| Scrub Area No.2 | Cordyline<br><i>Cordyline australis</i><br>Bramble spp<br><i>Rubus</i> | It consists of an area of scrub, predominately Bramble which has formed out from the field boundaries.<br>It is of an early mature age class in fair/ poor condition physiologically and poor condition structurally. Cordyline trees are establishing through this Bramble most likely from seed.<br><table><tr><td>A4</td><td>--</td><td>--</td><td>--</td></tr></table><br> | | | | | | | | | | A4 | -- | -- | -- | It would benefit from tidying and clearing up back into the hedge line. | -- | C1 | -- |

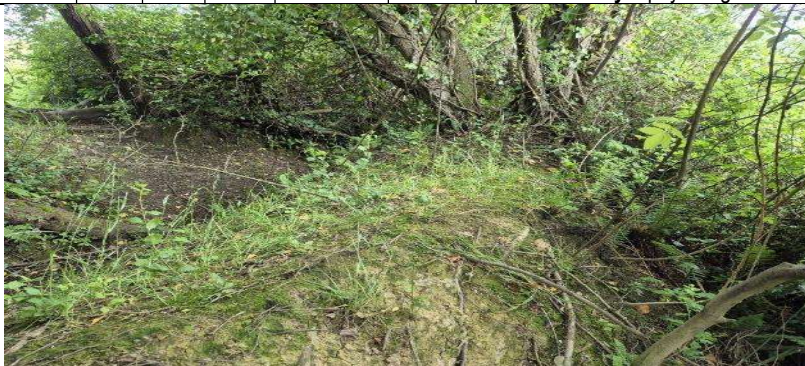
| Tree No. | Tree Species | Ht (m) | Stem Dia | Branch Spread (m) | | | | C - Ht. (m) | Age Class | Phys Con | Structural Comments | Preliminary Recommendations | ULE | Cat Grade | RPA (m) | |
|---|---|---|---|---|---|---|---|---|---|---|---|---|---|---|---|---|
| | | Shows central hedge bank in hedge No.21. | | | | | | | | | | | | | | |

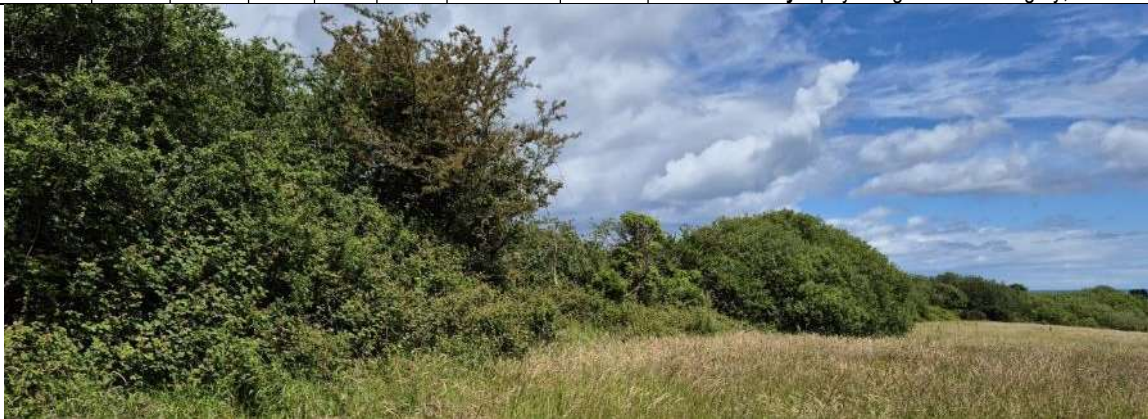
| Tree No. | Tree Species | Ht (m) | Stem Dia | Branch Spread (m) | | | | C - Ht. (m) | Age Class | Phys Con | Structural Comments | Preliminary Recommendations | ULE | Cat Grade | RPA (m) | | | | | |
|---|---|---|---|---|---|---|---|---|---|---|---|---|---|---|---|--|---|---|---|--|
| Tree Group No.1 | Goat Willow<br><i>Salix caprea</i><br>Hawthorn<br><i>Crataegus monogyna</i><br>Dog Rose<br><i>Rosa canina</i> | It is located between hedge No.25 & 26. It consists of an area of Willow which has grown up around a small wet land/ pond between hedge Nos.25 & 26.<br>They are of a mature age class in fair condition physiologically and structurally. Some of the Willow has been cut back in the past. The area has been allowed naturalise and provides some habitat value. The area is prone to water ponding during wet periods. | | | | | | | | | | It requires no work at the present time. | | | | | -- | B2 | 3.6 | |

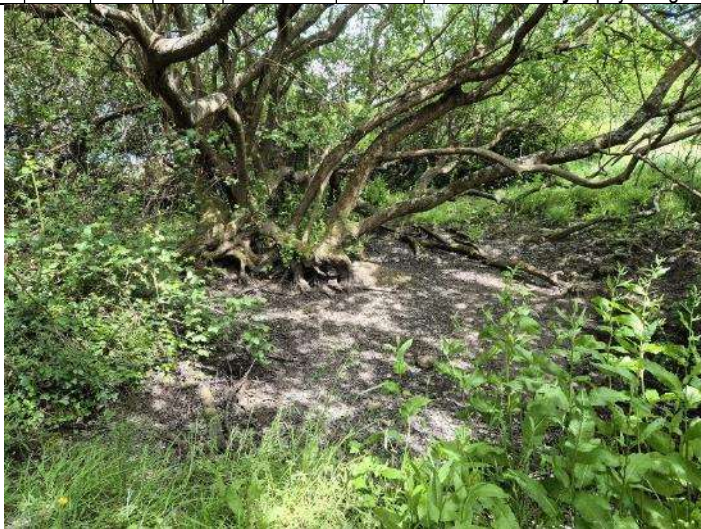
| Tree No. | Tree Species | Ht (m) | Stem Dia | Branch Spread (m) | | | | C - Ht. (m) | Age Class | Phys Con | Structural Comments | Preliminary Recommendations | ULE | Cat Grade | RPA (m) |
|---|---|---|---|---|---|---|---|---|---|---|---|---|---|---|---|
| T160 &161 | Goat Willow<br><i>Salix caprea</i> | A5 | A300 | A5 | A4 | A4 | A4 | A0 | Mature | Fair | Fair.<br>It consists of clumps of mature stems growing up on the edge. This area with these trees are separated from the main tree group by a body of water (pond) | They require no work at the present time. | 10+ | C2 | 3.54 |

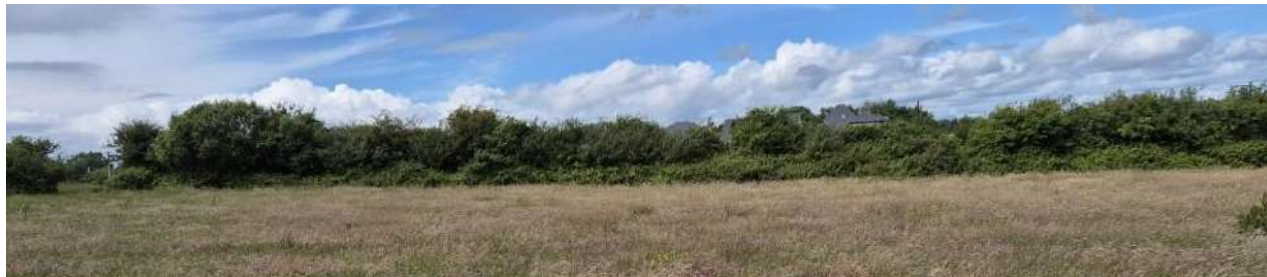
| Tree No. | Tree Species | Ht (m) | Stem Dia | Branch Spread (m) | | | | C - Ht. (m) | Age Class | Phys Con | Structural Comments | Preliminary Recommendations | ULE | Cat Grade | RPA (m) | |
|---|---|---|---|---|---|---|---|---|---|---|---|---|---|---|---|---|
| <b>Hedge No.27A</b> | <b>Hawthorn</b><br><i>Crataegus monogyna</i><br><b>Holly</b><br><i>Ilex aquifolium</i><br><b>Goat Willow</b><br><i>Salix caprea</i><br><b>Dog Rose</b><br><i>Rosa canina</i><br><b>Bramble spp</b><br><i>Rubus</i><br><b>Blackthorn</b><br><i>Prunus spinosa</i> | <b>It extends west at ninety degrees to hedge No.26 and forms the boundary between fields within the site area.</b><br>It is of a mature age class in fair condition physiologically and structurally. It is a dense hedge and provides good habitat value. It has had no recent works carried out and extends outwards into the fields on either side due to lapsed management. It is growing up along a ditch line. | | | | | | | | | | | It would benefit from general tidying works and trim in encroaching hedge species to contain width. | -- | B2 | 2.9 |

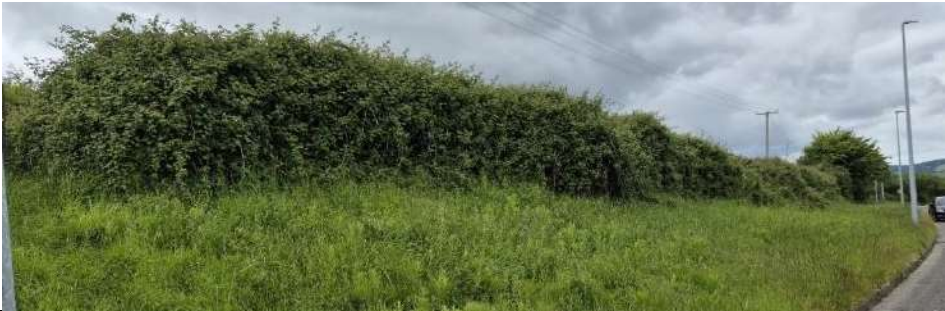
| Tree No. | Tree Species | Ht (m) | Stem Dia | Branch Spread (m) | | | | C - Ht. (m) | Age Class | Phys Con | Structural Comments | Preliminary Recommendations | ULE | Cat Grade | RPA (m) | | | | |
|---|---|---|---|---|---|---|---|---|---|---|---|---|---|---|---|---|---|---|---|
| Hedge No.29 | Bramble spp<br><i>Rubus</i><br>Hawthorn<br><i>Crataegus monogyna</i> | It extends along the fence line on the southern side of the access road.<br>It is of an early mature age class in fair condition physiologically and fair/ poor condition structurally. It has naturalised around the fence line over time and is heavily dominated by Bramble with some Hawthorn further along at the western end.<br><table><tr><td>A3</td><td>A100 x 3 stems</td><td>A2N, A2S,</td><td>0</td></tr></table> | | | | | | | | | | A3 | A100 x 3 stems | A2N, A2S, | 0 | It would benefit from cutting back the Bramble and infill planting to improve structure and quality. | -- | C2 | 2.1 |

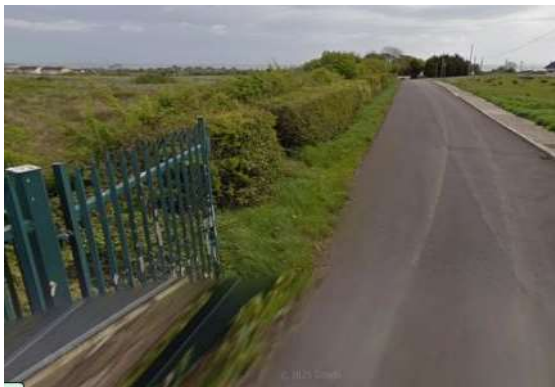
| Tree No. | Tree Species | Ht (m) | Stem Dia | Branch Spread (m) | | | | C - Ht. (m) | Age Class | Phys Con | Structural Comments | Preliminary Recommendations | ULE | Cat Grade | RPA (m) |
|---|---|---|---|---|---|---|---|---|---|---|---|---|---|---|---|
| Tree No.10 | <b>Ash</b><br><i>Fraxinus excelsior</i> | 7 | 120 | 2 | 2 | 2 | 2 | 1.5 | Semi Mature | Fair | Fair/ Poor<br>It is growing up within the hedge line; it shows some signs of 'Ash Dieback' within its crown. It forms higher bulking for the hedge. Inspection of the base or stem has not been possible due to dense undergrowth. | Management is outside the boundary of the site. | 10+ | C1 | 1.44 |
