# **Arborist Associates Ltd.**

## **An Arboricultural Assessment of the Tree and Hedge Vegetation on Lands at 'Money Little and Tinahask', Arklow, Co. Wicklow.**

**Prepared for: Castlethorn Arklow Limited (808309)**

**Date: 25<sup>th</sup> September 2026**

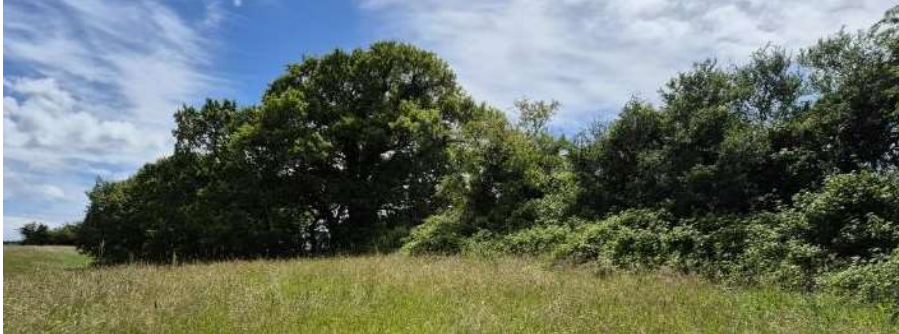
| Tree No. | Tree Species | Ht (m) | Stem Dia | Branch Spread (m) | | | | C - Ht. (m) | Age Class | Phys Con | Structural Comments | Preliminary Recommendations | ULE | Cat Grade | RPA (m) |
|---|---|---|---|---|---|---|---|---|---|---|---|---|---|---|---|
| T67 | <b>Beech</b><br><i>Fagus sylvatica</i> | 10 | 200/<br>100/<br>100/<br>100/<br>450 | 4 | 3 | 5 | 5 | 3 | Early<br>Mature | Fair/<br>Poor | Fair/ Poor<br>It is growing up on the hedgerow bank as part of hedge. It has grown from a stump/ stool with some other small minor stems. There are some decay points where stems failed in the past. It has a low squat crown form and its crown is sparse in foliage. | It requires no work at the present time. | 10+ | C1 | 6.3 |

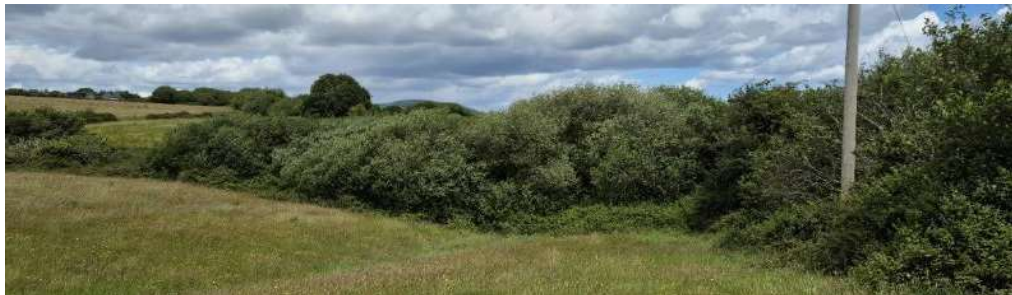
| Tree No. | Tree Species | Ht (m) | Stem Dia | Branch Spread (m) | | | | C - Ht. (m) | Age Class | Phys Con | Structural Comments | Preliminary Recommendations | ULE | Cat Grade | RPA (m) |
|---|---|---|---|---|---|---|---|---|---|---|---|---|---|---|---|
| Woodland No.1 | <b>Goat Willow</b><br><i>Salix caprea</i><br><b>Blackthorn</b><br><i>Prunus spinosa</i><br><b>Hazel</b><br><i>Corylus avellana</i><br><b>Bramble</b><br><i>Rubus fruticosus</i><br><b>Dog Rose</b><br><i>Rosa canina</i> | <b>It forms an intersection between hedge Nos.4, 5, 6 and Woodland No.2 and has merged with the hedges.</b><br>It is of an early mature age class in fair condition physiologically and structurally. It has expanded out on either side of the original townland boundary to create the current woodland block. It is dominated by Goat Willow and blackthorn and forms an area of dense cover with limited access. | | | | | | | | | | Requires no work at the present time. | -- | B2/ B3 | 4.0 |

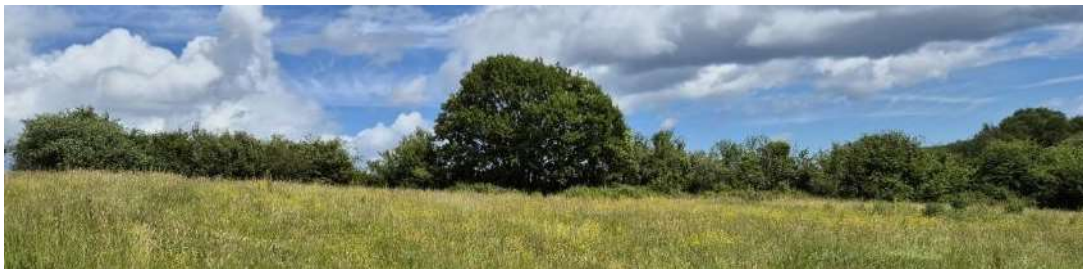
| Tree No. | Tree Species | Ht (m) | Stem Dia | Branch Spread (m) | | | | C - Ht. (m) | Age Class | Phys Con | Structural Comments | Preliminary Recommendations | ULE | Cat Grade | RPA (m) |
|---|---|---|---|---|---|---|---|---|---|---|---|---|---|---|---|
| Hedge No.6 | Hawthorn<br><i>Crataegus monogyna</i><br>Elm<br><i>Ulmus spp</i><br>Hazel<br><i>Corylus avellana</i><br>Holly<br><i>Ilex aquifolium</i><br>Bramble spp<br><i>Rubus</i><br>Dog Rose<br><i>Rosa canina</i><br>Blackthorn<br><i>Prunus spinosa</i><br>Goat Willow<br><i>Salix caprea</i> | It extends northwards from woodland No.1 to connect with Hedge No.7 forming a subdivision between the fields within the site area.<br>It is of a mature age class in fair condition physiologically and structurally. The main hedge line would appear to be on the north side of the drainage ditch with hedge species in particular Bramble and Blackthorn encroaching out. It has extended outwards from the original hedgerow line due to lapsed management. | | | | | | | | | | It would benefit from general tidying works and trim in encroaching hedge species to contain width. | -- | B2 | 3.6 |
| T89 | Oak<br><i>Quercus robur</i> | 14 | A400 x 6 stems | 5 | 6 | 5 | 6 | 3 | Early Mature | Fair | Fair<br>It is growing on the edge of a deep ditch. It is multi stemmed from the base and has begun to form above the hedge line. Access to its stem and base have not been possible due to the deep ditch which runs along its base and dense undergrowth. | It requires no work at the present time. | 20-40 | B1 | 11.7 |

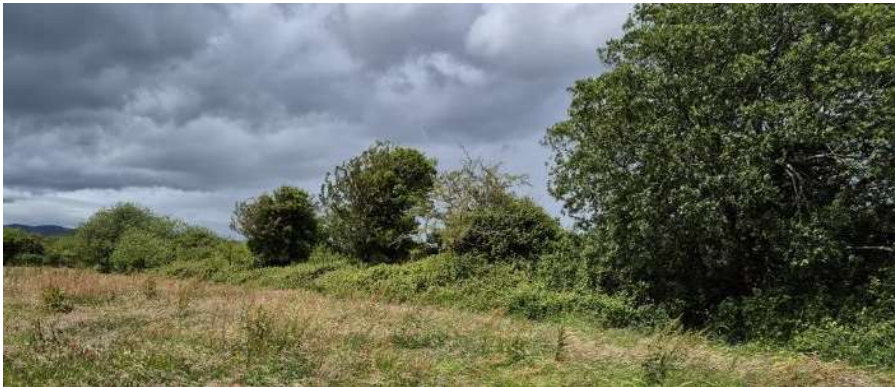
| Tree No. | Tree Species | Ht (m) | Stem Dia | Branch Spread (m) | | | | C - Ht. (m) | Age Class | Phys Con | Structural Comments | Preliminary Recommendations | ULE | Cat Grade | RPA (m) |
|---|---|---|---|---|---|---|---|---|---|---|---|---|---|---|---|
| T90 | <b>Goat Willow</b><br><i>Salix caprea</i> | 7 | 270 x 2 | | 3 | 5 | 1 | 1.8 | Mature | Fair | Poor<br>It is a twin stemmed tree from low down and it is growing out from the hedgerow bank. Its lower stem has spilt some time ago in a number of points and failed into the ditch. The remaining stem is more up right and was cut back in the past and has a number of smaller regrowth's developing. | Manage as part of the hedgerow bulking. | 10+ | C1 | 4.6 |
| T92 | <b>Goat Willow</b><br><i>Salix caprea</i> | 8 | 600 | 4 | 6 | 3 | 5 | 2 | Mature | Fair | Fair/ Poor<br>Its upper crown was reduced or failed in the past. Its lower stem has some decay at old stem unions. It | It may need to be cut/ coppiced in the | 10+ | C1 | 7.2 |

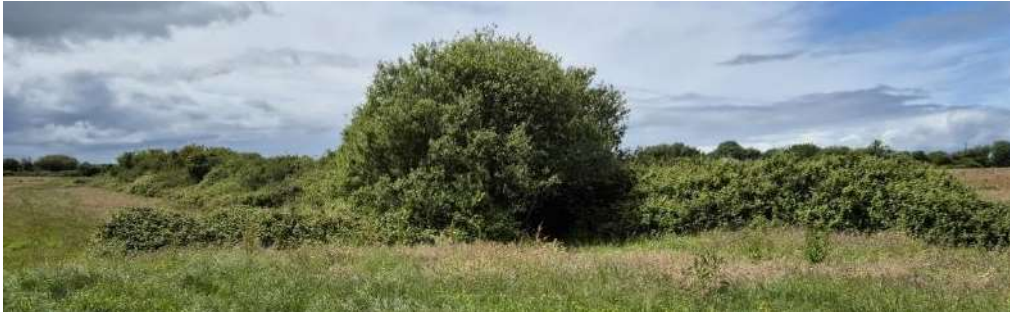
| Tree No. | Tree Species | Ht (m) | Stem Dia | Branch Spread (m) | | | | C - Ht. (m) | Age Class | Phys Con | Structural Comments | Preliminary Recommendations | ULE | Cat Grade | RPA (m) |
|---|---|---|---|---|---|---|---|---|---|---|---|---|---|---|---|
| | <i>Crataegus monogyna</i><br><b>Blackthorn</b><br><i>Prunus spinosa</i><br><b>Dog Rose</b><br><i>Rosa canina</i><br><b>Privet</b><br><i>Ligustrum vulgare</i><br><b>Goat Willow</b><br><i>Salix caprea</i> | It is of a mature age class in fair condition physiologically and fair/ poor condition structurally. It has been suppressed by Bramble in parts and Bramble is encroaching out from the hedge to create a broad hedge. | | | | | | | | | | | | | |
| T94 | <b>Willow</b><br><i>Salix spp</i> | 8 | 6st A270 | 5 | 5 | 5 | 4 | 2 | Early Mature | Fair | Fair/ Poor<br>It is located on the south side of the main hedge line. It is multi stemmed from low down and it has seeded out from the main hedge line. Some of its stems have collapsed/ failed but are still growing. | Tidy up failed stems and undergrowth. | 10+ | C1 | 7.9 |

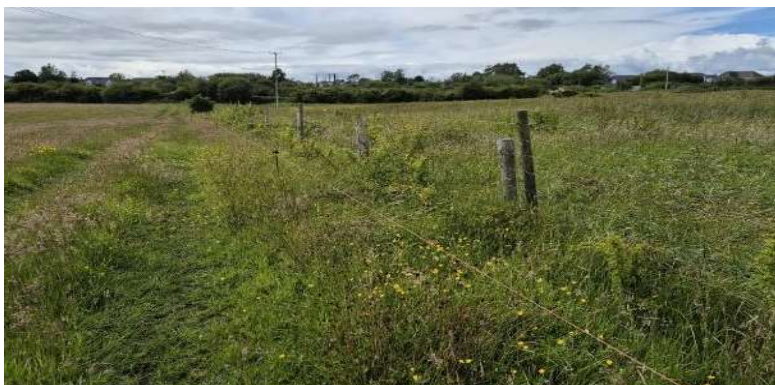
| | | | | | | | | | | | | | | | | |
| Tree No.6 | Oak<br>Quercus robur | 6 | #150 | 2 | 2 | 2 | 2 | 0.5 | Young | Fair | Fair<br>It is growing up within the open field out from the boundaries, I suspect it seeded naturally. The area around it has gone unmanaged and it has naturalised as a result. | It requires no work at the present time. | 40+ | C1 | 1.8 | | | | |
| Hedge No.18 | Hawthorn<br>Crataegus monogyna | It extends east west between fields within the site area.<br>It is of a young age class having been recently planted in fair condition physiologically and structurally. It is growing along the wire fence line which divides the fields. It is suppressed by grass and weeds along its base.<br><table><tr><td>A1</td><td>--</td><td>A0.5N, A0.5S</td><td>--</td></tr></table><br>

| | | | | | | | | | | | | | A1 | -- | A0.5N, A0.5S | -- |
| A1 | -- | A0.5N, A0.5S | -- | | | | | | | | | | | | | | | | |
| | | | | | | | | | | | | Pull back/ weed around its base. Provide a slow-release fertiliser and mulch the area to suppress weed growth. | -- | C1 | -- | | | | |

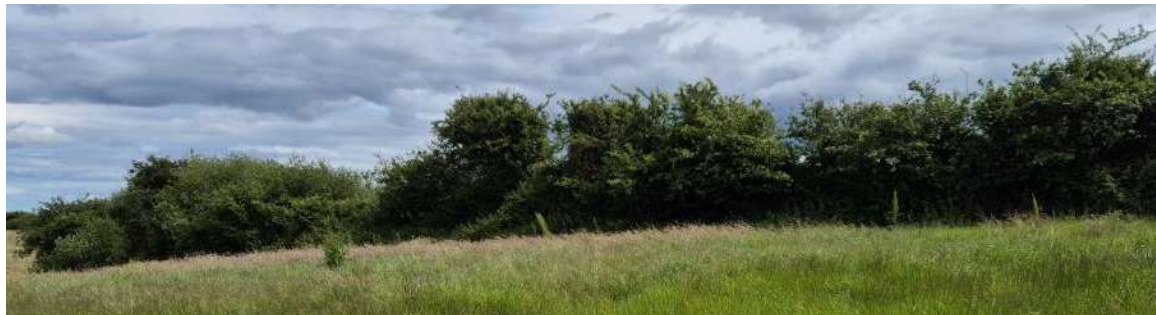
| Tree No. | Tree Species | Ht (m) | Stem Dia | Branch Spread (m) | | | | C - Ht. (m) | Age Class | Phys Con | Structural Comments | Preliminary Recommendations | ULE | Cat Grade | RPA (m) | |
|---|---|---|---|---|---|---|---|---|---|---|---|---|---|---|---|---|
| <b>Hedge No.20</b> | <b>Hawthorn</b><br><i>Crataegus monogyna</i><br><b>Common Gorse</b><br><i>Ulex Europeaus</i><br><b>Hazel</b><br><i>Corylus avellana</i><br><b>Blackthorn</b><br><i>Prunus spinosa</i><br><b>Dog Rose</b><br><i>Rosa canina</i><br><b>Goat Willow</b><br><i>Salix caprea</i><br><b>Cherry</b><br><i>Prunus spp</i><br><b>Hazel</b><br><i>Corylus avellana</i> | <b>It runs at ninety degrees to hedge No.19 and forms the boundary between fields within the site area.</b><br>It is of a mature age class in fair condition physiologically and structurally. It follows the sloping topography of the site and forms part of the townland boundary that runs through the site area. It has grown out into the fields from lapsed management and it forms a dense hedge with a mixed species composition. At the south eastern end, a section has been pulled out creating a break in the hedge line. The main hedge line would appear to be on the west side of the field drainage ditch. | | | | | | | | | | It would benefit from general tidying works and trim in encroaching hedge species to contain width of hedge. | | -- | B2/<br>B3 | 4.3 |

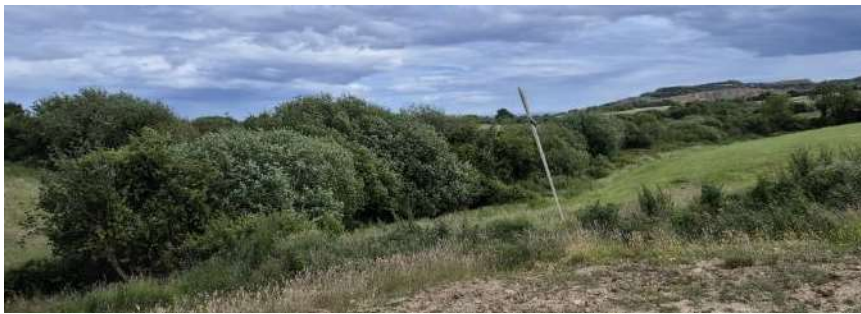
| Tree No. | Tree Species | Ht (m) | Stem Dia | Branch Spread (m) | | | | C - Ht. (m) | Age Class | Phys Con | Structural Comments | Preliminary Recommendations | ULE | Cat Grade | RPA (m) |
|---|---|---|---|---|---|---|---|---|---|---|---|---|---|---|---|
| Hedge No.21 | Hawthorn<br><i>Crataegus monogyna</i><br>Goat Willow<br><i>Salix caprea</i><br>Bramble spp<br><i>Rubus</i><br>Hazel<br><i>Corylus avellana</i><br>Blackthorn<br><i>Prunus spinosa</i><br>Bramble<br><i>Rubus fruticosus</i><br>Dog Rose<br><i>Rosa canina</i> | It extends southwards from hedge No.20 to connect up with hedge No.22 and forms a boundary between the fields within the site area.<br><br>It is of a mature age class in fair condition physiologically and structurally. It forms part of the townland boundary that runs through the site area. It has a main hedge soil bank running between two ditches with the main ditch appearing to be on the east side of the hedge. It has good vitality and it has extended out on either side particularly with Bramble due to lapsed management. It forms a good wildlife corridor. | | | | | | | | | | It would benefit from general tidying works and trim in encroaching hedge species to contain width of hedge. | -- | B2/<br>B3 | 4.3 |

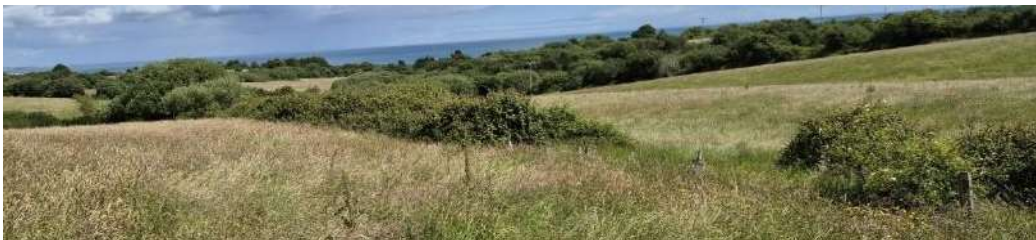
| Tree No. | Tree Species | Ht (m) | Stem Dia | Branch Spread (m) | | | | C - Ht. (m) | Age Class | Phys Con | Structural Comments | Preliminary Recommendations | ULE | Cat Grade | RPA (m) | | | | |
|---|---|---|---|---|---|---|---|---|---|---|---|---|---|---|---|---|---|---|---|
| T158 &159 | Goat Willow<br><i>Salix caprea</i> | 5 | 100, 100, 120, 120, 130, 80, 110 | 5.5 | 6 | 5 | 6 | 0.5 | Early Mature | Fair | Fair<br>They have self-seeded here and are growing up along the wire fence line. They form one crown and they were cut back in the past and regrown. The area to their east is partly dense with Bramble. | They require no work at the present time. | 10-20 | C1 | 3.48 | | | | |

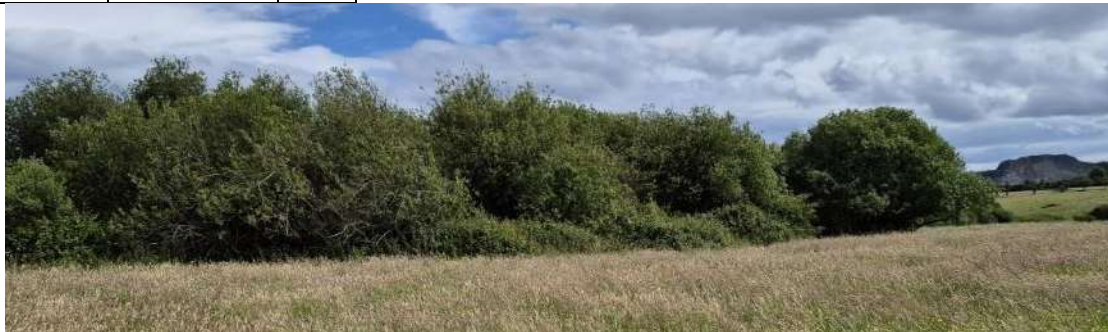
| Tree No. | Tree Species | Ht (m) | Stem Dia | Branch Spread (m) | | | | C - Ht. (m) | Age Class | Phys Con | Structural Comments | Preliminary Recommendations | ULE | Cat Grade | RPA (m) | | | | | |
|---|---|---|---|---|---|---|---|---|---|---|---|---|---|---|---|--|---|---|---|--|
| Tree Group No.1 | Goat Willow<br><i>Salix caprea</i><br>Hawthorn<br><i>Crataegus monogyna</i><br>Dog Rose<br><i>Rosa canina</i> | It is located between hedge No.25 & 26. It consists of an area of Willow which has grown up around a small wet land/ pond between hedge Nos.25 & 26.<br>They are of a mature age class in fair condition physiologically and structurally. Some of the Willow has been cut back in the past. The area has been allowed naturalise and provides some habitat value. The area is prone to water ponding during wet periods. | | | | | | | | | | It requires no work at the present time. | | | | | -- | B2 | 3.6 | |

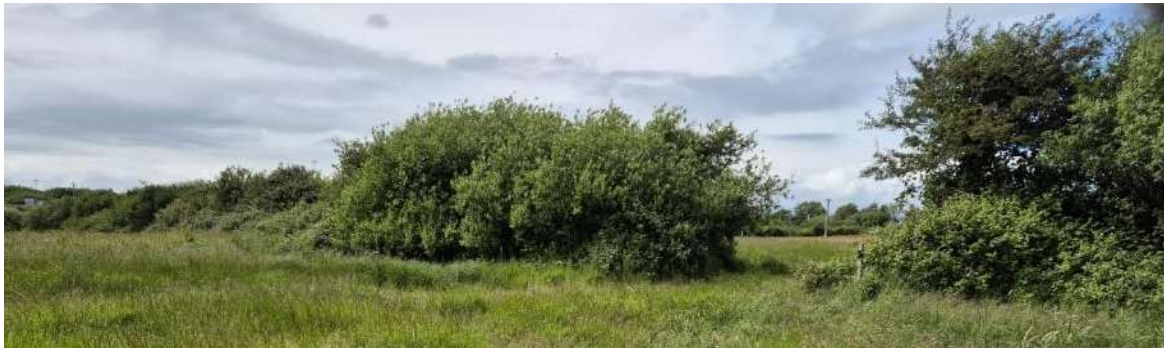
| Tree No. | Tree Species | Ht (m) | Stem Dia | Branch Spread (m) | | | | C - Ht. (m) | Age Class | Phys Con | Structural Comments | Preliminary Recommendations | ULE | Cat Grade | RPA (m) | | | | |
|---|---|---|---|---|---|---|---|---|---|---|---|---|---|---|---|---|---|---|---|
| T162 | <b>Grey Willow</b><br><i>Salix cinerea</i> | 6 | 570 | 4.5 | 4 | 3 | 3.5 | 0.5 | Mature | Fair | Fair/ Poor<br>It is growing up within the hedge line. It is an older tree, growing from an old root stock. It splits into 2 stems at circa 1m and has poor formed union here with some minor decay and bark dieback. Its root zone has been impacted by livestock in the past. | It requires no work at the present time. Monitor its condition and reinspect in 12 months. | 10+ | C2 | 6.9 | | | | |

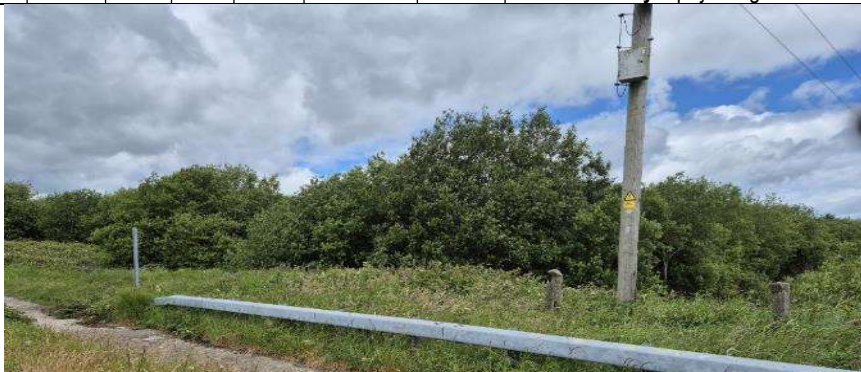
| Tree No. | Tree Species | Ht (m) | Stem Dia | Branch Spread (m) | | | | C - Ht. (m) | Age Class | Phys Con | Structural Comments | Preliminary Recommendations | ULE | Cat Grade | RPA (m) | | | | |
|---|---|---|---|---|---|---|---|---|---|---|---|---|---|---|---|---|---|---|---|
| Woodland No.3 | <b>Goat Willow</b><br><i>Salix caprea</i><br><b>Blackthorn</b><br><i>Prunus spinosa</i><br><b>Bramble spp</b><br><i>Rubus</i><br><b>Common Gorse</b><br><i>Ulex Europeaus</i><br><b>Hawthorn</b> | <b>It consists of an area of self-seeded naturalised scrub, growing along the side of the access road.</b><br>It is of an early mature age class in fair condition physiologically and structurally. It has received no maintenance and suffered from anti-social behaviour within it. <table><tr><td>A6</td><td>A100</td><td>A3N, A3S, A3E, A3W</td><td>A1</td></tr></table> | | | | | | | | | | A6 | A100 | A3N, A3S, A3E, A3W | A1 | It would benefit from management to combat dumping and anti-social behaviour issues. | -- | B2/ B3 | 1.2 |

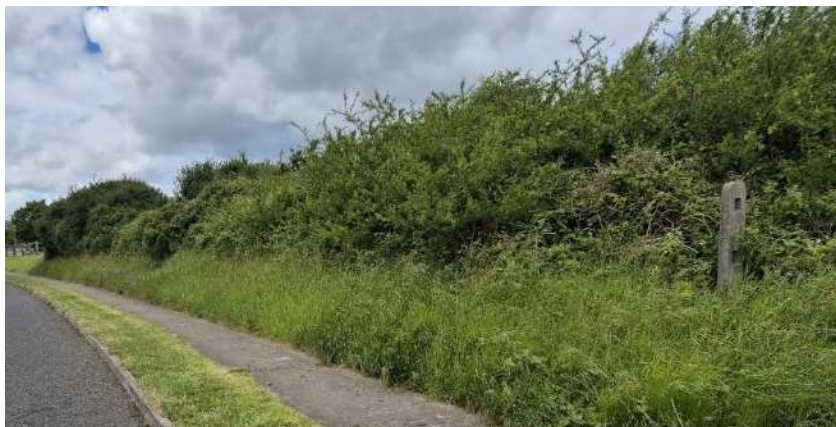
| | | | | | | | | | | | | | | | | | |
| Hedge No.28 | <b>Blackthorn</b><br><i>Prunus spinosa</i><br><b>Bramble spp</b><br><i>Rubus</i><br><b>Common Gorse</b><br><i>Ulex</i><br><i>Europeaus</i><br><b>Hawthorn</b><br><i>Crataegus monogyna</i> | It consists of a short section of hedge bounding the open space of the neighbouring residential development and is located west of woodland No.3 .<br>It has been trimmed for clearance from the footpath, creating the hedge structure. | | | | | | | | | | Continue present maintenance. | -- | C2 | 2.1 | | | | | | | |
| | | | | <table border="1"><tr><td>A6</td><td>A100 X 3 stems</td><td>A2.5N, A3S,</td><td>--</td></tr></table> | | | | A6 | A100 X 3 stems | A2.5N, A3S, | -- | | | | | | | | | | | |
| A6 | A100 X 3 stems | A2.5N, A3S, | -- | | | | | | | | | | | | | | | | | | | |
| | | | |
